# Manhole Inspection Summary

Manhole # S31UU\_029MH

Insp Date: **5/8/07 12:22 PM**

**Location** Address: **333 FOX ST**

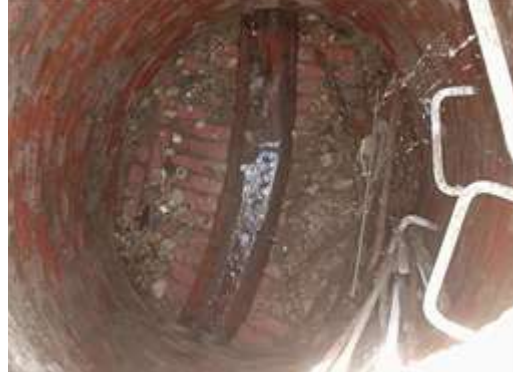
Top View

Bench debris.

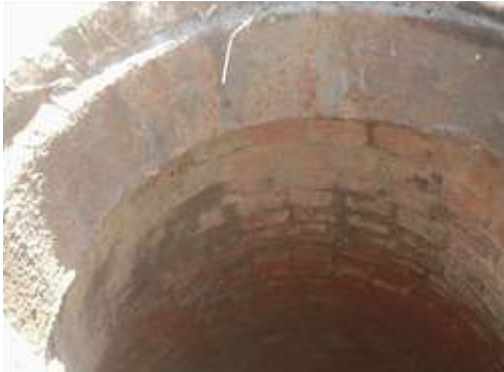
Defect

Frame leaks. Frame offset. Adjustment deterioration and infiltration. Corbel and Barrel infiltration - other side.

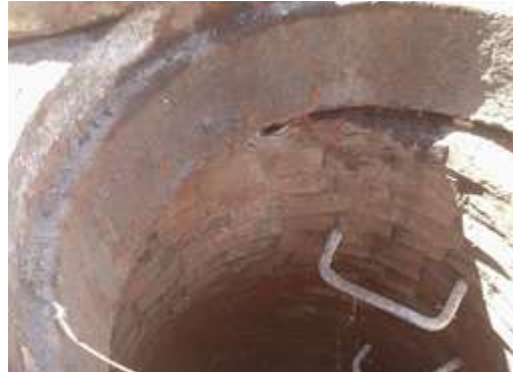
Defect

Frame leaks. Frame offset. Adjustment deterioration and infiltration. Corbel and Barrel infiltration.

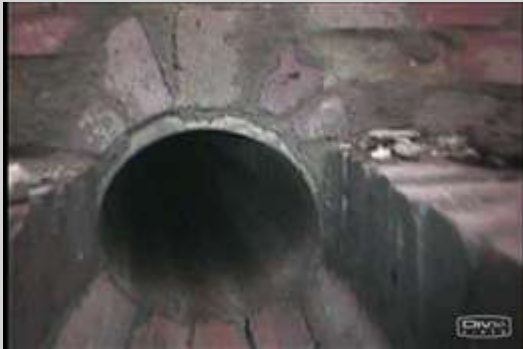
### 8 in. Circular Gravity Sewer Pipe Out @ 12 O'Clock

Infiltration: **None** Pipe Seal Cond: **Unknown**

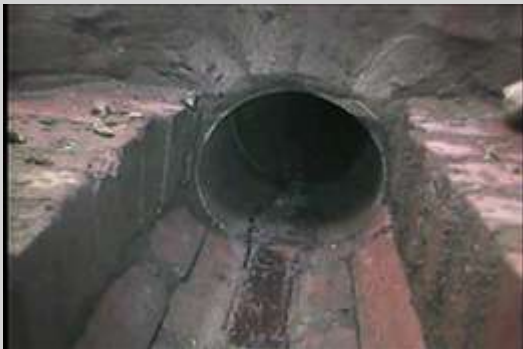
### 8 in. Circular Gravity Sewer Pipe In @ 7 O'Clock

Infiltration: **Evidence** Pipe Seal Cond: **Unknown**
